Journal of the Croatian Geological Survey

The preliminary inventory of coseismic ground failures related to December 2020 – January 2021 Petrinja earthquake series

doi: 10.4154/gc.2021.08

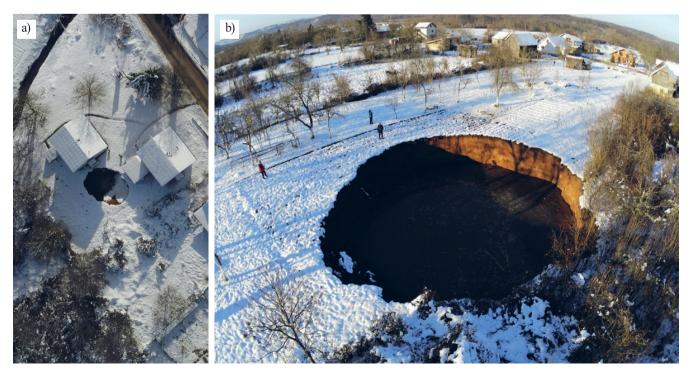
At the time of writing this manuscript, 35 records were entered in the inventory (Figure 4, Table 1), but up to February 15th 2021, more than ninety (90) subsidence dolines were registered in the area between Borojevići and Mečenčani in the Donji Kukuruzari municipality. The great majority of these are classified as dropout dolines formed by the sudden (or over a few hours) collapse of cover sediments into the underground voids, forming steep-sided cylindrical depressions. The majority of the dolines are between 1 and 10 m in diameter, but the largest one is more

Figure 4. Dropout dolines in Mečenčani village: a) endangering adjacent houses (observation point IK31), b) the biggest doline, more than 20m in diameter and about 12 m deep (observation point IK4).

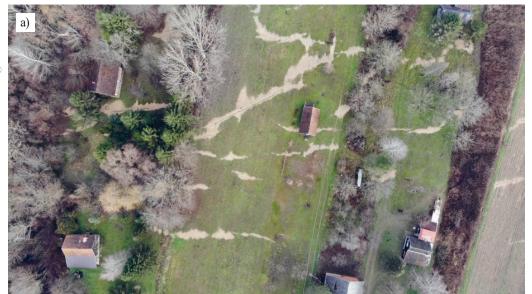
Figure 5. The sand boiling features along linear fractures: a) in Letovanić (aerial photo); b) in Sisak (observation point Si-04).

quake Glossary, 2021). The research area exhibited many locations with such features, eighty-five are in the database at present (Table 2). Most of the sand boils are aligned in a row along a linear fracture exposed at the surface (Figure 5). Locations of sand boil phenomena are found in several areas adjacent to the rivers Sava, Kupa and Glina and are clear indications of liquefied zones.

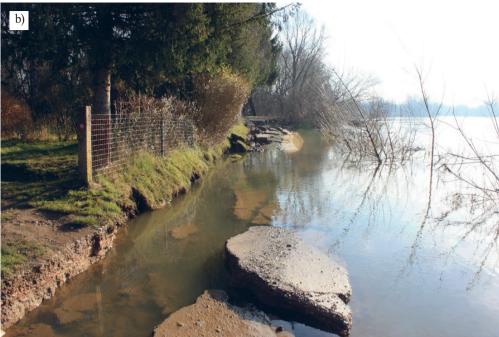
Here, the lateral spreading is the result of liquefaction of the saturated and loose sandy layers, and occurred on the flood embankments of the river Sava but also on the natural Kupa and Petrinjčica river banks (Figure 6). Horizontal displacements in most of the cases are from a few centimetres to several decimetres.

Figure 6. Lateral spreading and associated processes: a) failure of the flood embankment in Sisak (observation point Si-03); b) road failure in Letovanić (observation point RMT-35).

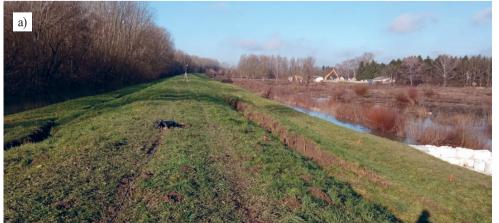
Subsidence caused by liquefaction is related to larger liquified zones and is registered at six sites. It is recognised or suspected in populated areas of Petrinja (Vinogradska and Milana Makanca street zones), Sisak and at the edges of smaller settlements Stari Brod, Letovanić, Brest, Drenčina and Palanjek. According to our knowledge, the vertical displacements in densely populated areas are up to 10 centimetres. Larger vertical displacements of several decimetres are noted in the immediate vicinity of the Kupa and Sava rivers (Figure 7).

Figure 7. Subsidence and lateral spreading of the embankments near the Sava river: a) in Sisak (observation point Si-03); b) in Palanjek (observation point NP-21).

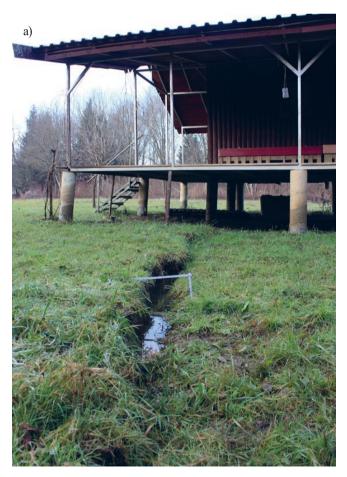
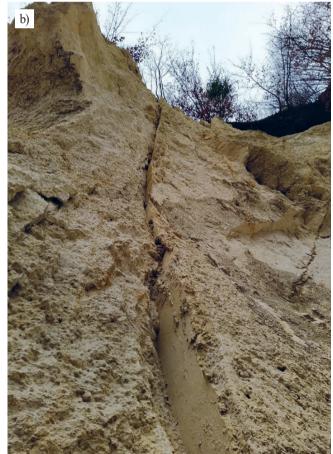
A number of soil ruptures are observed in various lithologies (Figure 2). In general, two types of soil ruptures can be differentiated. The first group comprises ruptures closely related to the main seismogenic fault zone that triggered the major earthquake. The second group comprises soil ruptures that are related to liquified zones and surface subsidence. Fracture displacements are usually up to a few centimetres, rarely several decimetres (Figure 9).

Figure 9. Soil rupture: a) near Letovanić (observation point RMT-38); b) near Župić village (observation point MV-11).

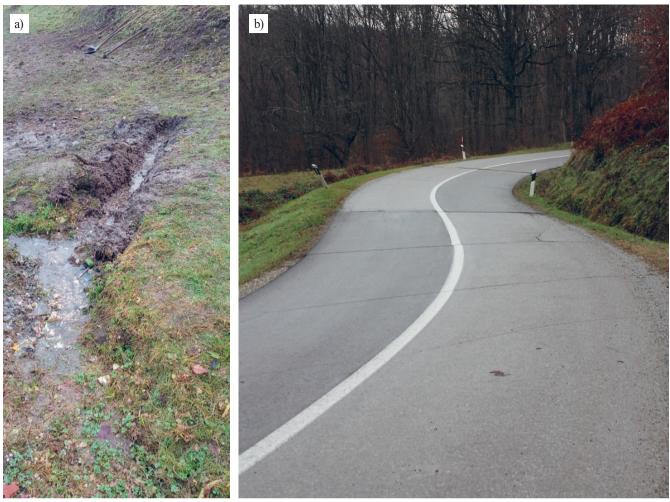
At a single location in Hrastovica, the displacement or clouding of springwater is registered. Here, before the main earthquake, the groundwater catchment collected all waters above the family house, but after intensive ground shaking, the groundwater emergence was scattered in a wider zone causing groundwater eruption inside and around the family house (Figure 10a).

Numerous road ruptures are also registered (Figure 10b). The great majority of these fractures are in the wider zone of the activated seismogenic fault (Figure 2). Other road ruptures follow minor, local faults, or are related to liquefaction-induced subsidence.

Figure 10. a) clouding of springwater in Hrastovica (observation point HR-DN-01); b) road ruptures near Pokupsko Vratečko (observation point RMT-43).

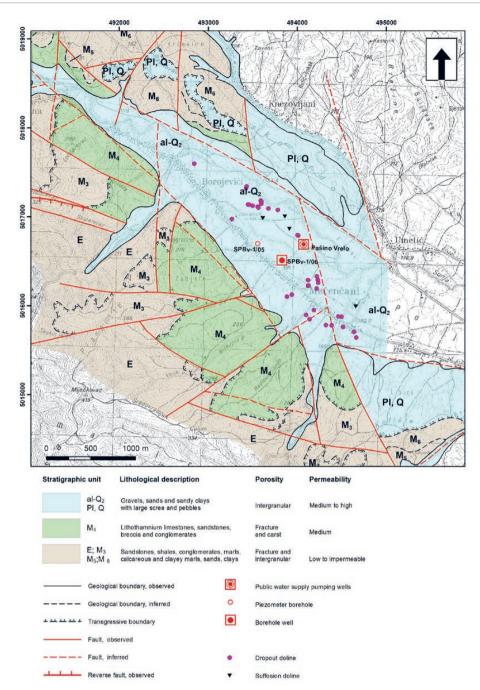
The subsidence dolines are exclusively found in the area around the villages of Mečenčani and Borojevići. This area was surveyed in detail during the hydrogeological investigations for Pašino vrelo (ŠIMUNOVIĆ & HEĆIMOVIĆ, 1998; MRAZ, 2005; MRAZ et al., 2007; LARVA et al., 2010). The terrain is characterised by alluvial and proluvial sediments (al-Q₂) which overlie Miocene rocks (Figure 11). Freshly exposed steep banks of newly formed dolines facilitate understanding of the nature of alluvial sediments which are soil mixtures of various fractions from clay to gravel. The thickness of these deposits varies from several to ~15 metres in the vicinity of the river Sunja. Older Miocene deposits (M₃) are represented by clayey sands and clays. They are overlain by M₄ deposits, beginning with conglomerates or breccias followed by Lithothamnium limestones. According to geophysical investigations, those limestones are more than 100 m thick in some parts (KRSNIK, 2005).

Figure 11. The distribution of subsidence dolines in the wider Mečenčani and Borojevići area on the geological map (originally in the scale 1:5 000; MRAZ, 2005).

In addition, monitoring of the area should be established. Monitoring should include periodic remote sensing, groundwater level monitoring and monitoring of ground shaking intensity. These data, with the results of the other aforementioned investi-
