# Large gravitational collapse structure on a rocky coast (Kvarner, NE Adriatic Sea)

doi: 10.4154/gc.2023.10

## Abstract

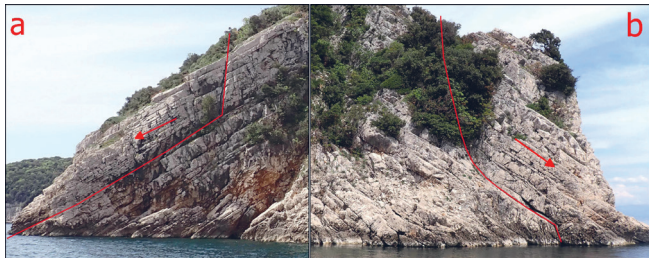
**Figure 5.** Structural interpretation of a possible slide in layered Upper Cretaceous limestones: a) south side, b) north side. Both red arrows are oriented to the east.

Rock mass surrounding the rock collapse consists of the Upper Cretaceous rudist limestones. The limestones show a distinct layering, with bedding planes uniformly inclined to the southeast with a dip angle of 28°. The layers are 10 to 100 cm thick. In addition to bedding planes, vertical or oblique fissures are also visible. This kind of structural fabric can favour the collapse of both sides of the described collapse structure (Figures 5a and 5b).

driven waves, discontinuities likely serve as initial patterns for the development of instability. Discontinuities that are diagonal to bedding planes, and discontinuity planes with dip vectors that form an oblique dihedral angle with the bedding planes dip vector, both contribute significantly to the development of instability. The aforementioned discontinuities are more persistent than others and run transverse to the bedding plane (Figure 5).
