Journal of the Croatian Geological Survey

The preliminary inventory of coseismic ground failures related to December 2020 – January 2021 Petrinja earthquake series

doi: 10.4154/gc.2021.08

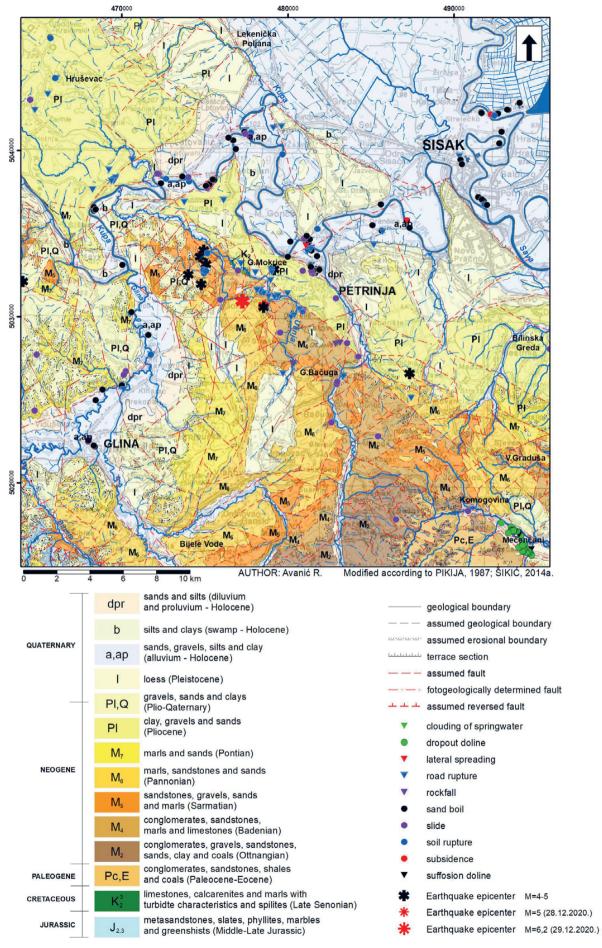
Figure 2. The geological map of the research area (originally in the scale 1:100.000) with the locations of ground failures.

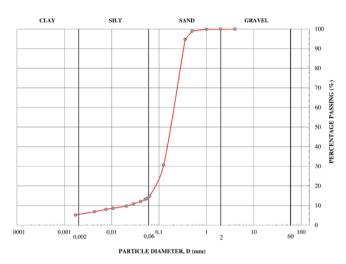
Figure 12. Granulometric diagram of sand boil material sampled at the surface in Brest Pokupski. The analysis is done in accordance with HRN EN ISO 17892-4:2016 norm.

The alluvium of these recent rivers is dominated by pure sands, only locally by silts. Siltose or gravelly sands, and lenses of pure gravels are also observed (PIKIJA et al., 1986). The material ejected at the surface is predominantly classified as pure sand, which is confirmed by granulometry laboratory analysis (Figure 12).

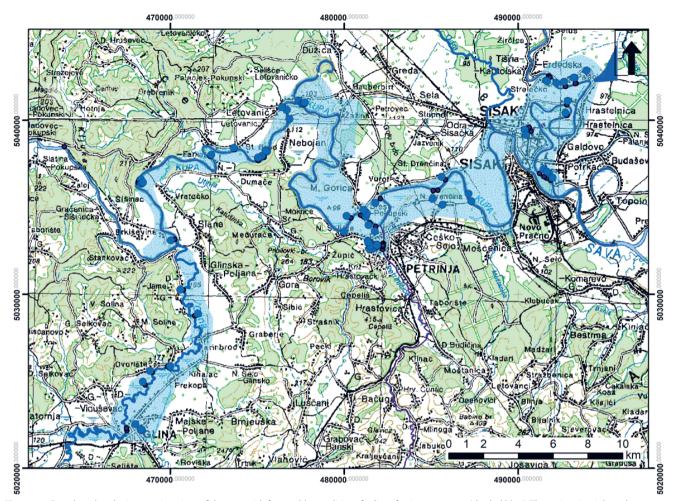
Considering all the collected data in the research area, favourable conditions for liquefaction are related to the Sava, Kupa and Glina alluvium or floodplain sediments which, according to rough and preliminary estimations cover more than 100 km² (Figure 13). The presented map is based solely on current database records and existing geological data at the scale of 1:100.000 and should be considered as a rough estimation. Detailed studies are needed in order to define liquefaction susceptibility zones and mitigation measures.

Figure 13. Rough and preliminary estimations of the area with favourable conditions for liquefaction processes (shaded blue). The estimation is based on recent surface processes caused by liquefaction (blue dots) and existing Basic Geological Map in the scale 1: 100.000.
